**EIKENHOF QUARRY ENVIRONMENTAL  
MANAGEMENT PROGRAMME - GP  
30/5/1/2/2(225)MRC**

Environmental Compliance Audit

PROJECT NO. 41104712

DATE: MARCH 2023

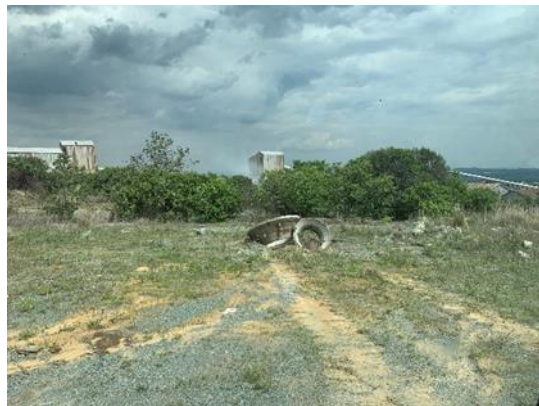
<p><b>Figure 2-1 - Salvage yard</b></p>	Y	None	N

Topography and visual	<p>Implement good housekeeping through ensuring:</p> <ul style="list-style-type: none"> <li>All salvageable material is stored in the designated area (salvage yard).</li> <li>Raw material for the workshops must be stored in their designated areas.</li> </ul>	Daily	<b>C</b>	<p>It was observed during the site inspection that all raw materials are stored accordingly in the designated areas. Salvageable material was also observed to be stored in the designated salvage yard. However, the salvage yard was mostly empty at the time of the audit, due to the risk of theft.</p> <p><i>Evidence:</i></p> <ul style="list-style-type: none"> <li>Onsite observation:</li> </ul>

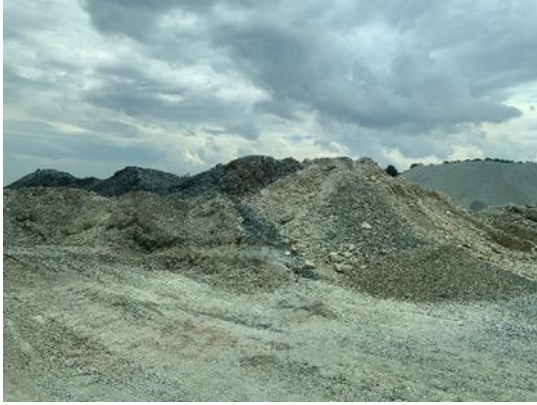
<p><b>Figure 2-2 - Raw material storage at processing plant</b></p>					
	Topography and visual	Implement the Waste Management Plan as per Section 11.3.8, i.e.: <ul style="list-style-type: none"> <li>Adequate waste storage facilities are available.</li> <li>All waste is stored in the designated areas.</li> <li>The volumes of waste is monitored and disposed of prior to exceeding the storage facility capacity.</li> <li>Disposed prior to exceedance of storage capacity.</li> </ul>	LoM	NC	Adequate waste storage facilities in the form of bins in strategic locations were observed throughout the site. However, overflowing waste skips were observed at the time of the audit.  <i>Evidence:</i> <ul style="list-style-type: none"> <li>Onsite observation:</li> </ul>

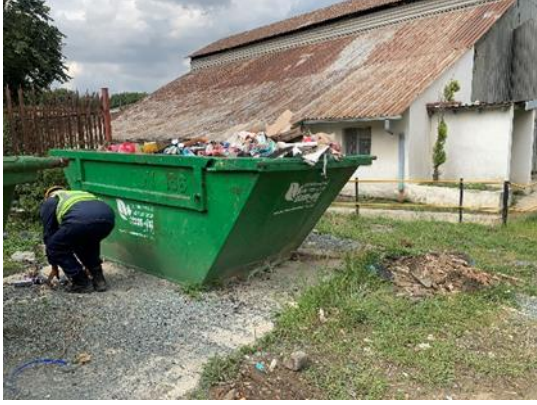
<p><b>Figure 2-3 - Overflowing waste bin</b></p>

Topography and visual	If poor housekeeping is identified, corrective action must be taken.		C	<p>The good housekeeping commitments have not been fully adhered to as multiple overflowing waste skips were observed at the time of the audit.</p> <p>The auditor was verbally informed that corrective action, removal of the waste, was undertaken subsequent to the audit.</p> <p><i>Evidence:</i></p> <ul style="list-style-type: none"> <li>Onsite observation: <b>Figure 2-3</b> and <b>Figure 2-4</b></li> </ul>	Y	None	N		
	Topography and visual	Implement concurrent rehabilitation, as per Section 11.5.		C	<p>The Rehabilitation Progress Report outlines the ongoing rehabilitation measures being undertaken.</p> <p>Monitoring is undertaken on a quarterly basis to determine further rehabilitation measures and the success of existing measures.</p> <p>A copy of the Alien Vegetation Control and Concurrent Rehabilitation Progress Report was provided which outlines the ongoing rehabilitation measures being undertaken. However, the report states that no concurrent rehabilitation was undertaken for the reporting period. The work is focussed on alien species identification and control.</p> <p><i>Evidence:</i></p> <ul style="list-style-type: none"> <li>Alien Vegetation Control and Concurrent Rehab Jul-Sep 2022</li> <li>Final rehabilitation, decommissioning and mine closure plan, compiled by Shangoni Management Services (Pty) Ltd, November 2016</li> </ul>	Y	None	N

Y	It is recommended that all waste is disposed of before the waste in/skips overflow. A record of collection by a registered waste management facility must also be kept.	N	Short term	YC Mgxekwa

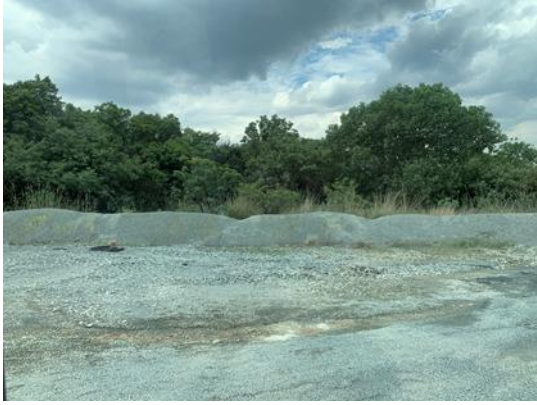
<p>Figure 2-5 - Stormwater berm at stockpile area</p>

EMPR Ref:	Activity	Commitment	Timeframe	Compliance	Finding	Is the Commitment relevant to the Site? (Y/N)	Recommendations	Amendment Required (Y/N)	CLOSE OUT TIMEFRAME	RESPONSIBILITY (INCLUDING CLOSE-OUT DATE)
		<ul style="list-style-type: none"> <li>Minimise erosion or leaching of materials from any residue deposit or stockpile [Reg7(e) GN704]; and</li> <li>Prevent uncontrolled discharge of “dirty” water from the mining site [S 19(2)(c) NWA &amp; Reg4(d) &amp; Reg7(e) GN704].</li> </ul>			<ul style="list-style-type: none"> <li>Stormwater Management Plan, compiled by M2ENCO, September 2016</li> <li>Onsite observation:</li> </ul>

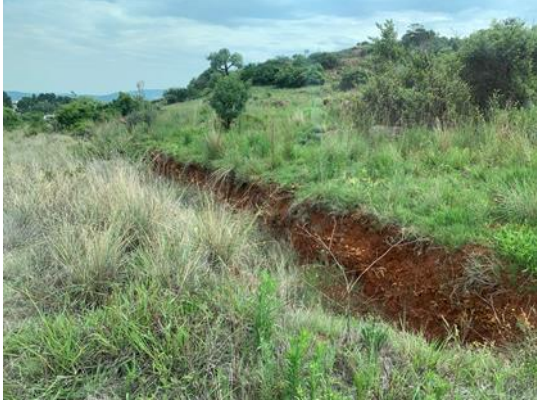
<p>Figure 2-6 - Storm water trench</p>					
		Where pollution incidents are identified, the mine must “remedy the effects of the pollution” [S 19(2)(e) NWA]. See Section 16.5 for the response procedure in the event of emergency incidents.		N/A	<p>No environmental incidents were reported for the audit period</p> <p><i>Evidence:</i></p> <ul style="list-style-type: none"> <li>Incidents Register on SAPP</li> <li>Verbal confirmation</li> </ul>	Y	None	N

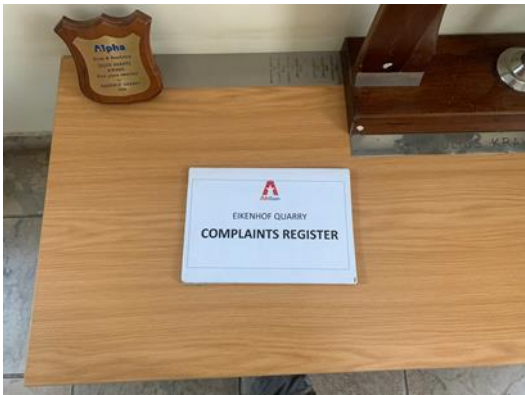
<p><b>Figure 2-8 - Complaints register kept at entrance to site offices</b></p>	Y	None	N

EMPR Ref:	Activity	Commitment	Timeframe	Compliance	Finding	Is the Commitment relevant to the Site? (Y/N)	Recommendations	Amendment Required (Y/N)	CLOSE OUT TIMEFRAME	RESPONSIBILITY (INCLUDING CLOSE-OUT DATE)
		Eikenhof Quarry will maintain a complaint register		C	<p>A complaints register is kept at the entrance to the main offices. No complaints were received during the audit period.</p> <p><i>Evidence:</i></p> <ul style="list-style-type: none"> <li>Onsite observation:</li> </ul>

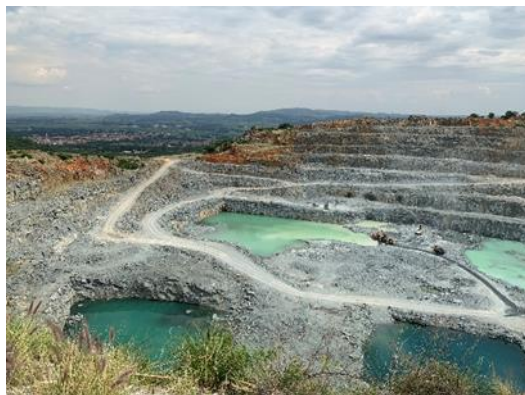
11.2.4 Loading, Hauling and Stockpiling of Blasted Material										
1	Dust	See Section 11.1.2 Materials handling and Haulage.		C	As per item 11.1.2 above	Y	None	N		
		Maintain haul roads as described in Section 11.3.5 Haul road maintenance.	LoM	C	All haul roads were observed to be well kept as per the requirements under condition 11.3.5.  <i>Evidence:</i> <ul style="list-style-type: none"><li>Onsite observation:</li></ul> <div>

</div> <b>Figure 2-9 - Haul roads within quarry pit</b>	Y	None	N		
2	Noise	See Section 11.1.3 Hours of Operation and Vehicles.		C	As per item 11.1.3 above.	Y	None	N		
		See Section 11.3.5 Vehicle and plant maintenance.		C	As per item 11.3.5 below.	Y	None	N		
		Where possible, vehicles must be fitted with noise abatement technology. The effectiveness of this must be confirmed during occupational health and safety monitoring.		C	It was verbally confirmed that all equipment, including vehicles are fitted with silencers. During the site investigation no excessively noisy vehicles were encountered.  <i>Evidence:</i> <ul style="list-style-type: none"><li>Verbal communication</li><li>Onsite observation – Vehicles</li></ul>	Y	None	N

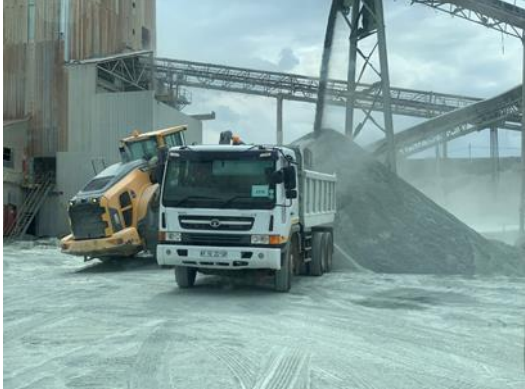
1.	Dust	For each product, identify the most significant source of dust during stockpiling, i.e. as the material leaves the belt, or as the material falls to the stockpile, or from the stockpile.	Within 2 months	C	<p>The most significant sources of dust were reported to be from stockpiling the fine product at the crushing plant.</p> <ul style="list-style-type: none"> <li>Verbal confirmation</li> <li>Onsite observation:</li> </ul>

<p><b>Figure 2-10 - Dust plumes at the crushing plant</b></p>	Y	OFI: Dust sources must be recorded in a comprehensive emissions inventory and reviewed at regular intervals.	N		
		Implement management measures (or a plan of implementation) to reduce the volume of dust available from this source.	Within 6 months	C	<p>Dust suppression activities were confirmed to be undertaken when required.</p> <p>The environmental monitoring reports, that include dust monitoring results, were also reviewed. The reports conclude that dust fallout limits were not exceeded during the audit period.</p> <p>Stockpiles were reported to not cause any significant dust fallout. No clouds of dust were observed at the stockpiles. Dust plumes were observed at the fines stockpile during tipping, however wetting of these is limited as wet product may block and damage the screens.</p> <p><i>Evidence:</i></p> <ul style="list-style-type: none"> <li>Verbal confirmation</li> <li>AfriSam Eikenhof Env. Monitoring Reports January 2022 – October 2022</li> </ul>	Y	None	N

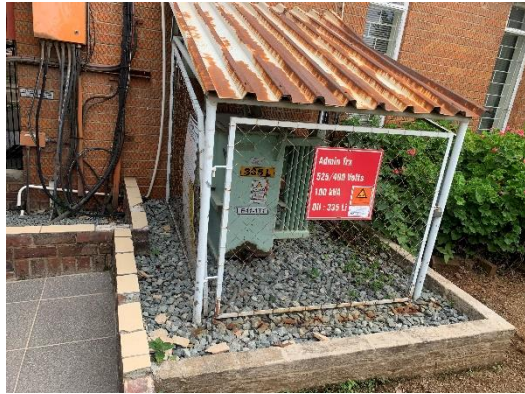
1.	Transformers:	All transformers and / or gensets are to be kept in concrete lined, preferably bunded, areas.		C	<p>The sub-station was observed to be kept in a bunded area, that is concrete lined.</p> <p>Evidence:</p> <ul style="list-style-type: none"> <li>Onsite observation:</li> </ul>

<p><b>Figure 2-12 - Sub-station bunded area</b></p>	Y	None	N		
		Any hydrocarbon spills are to be cleaned as described in Sec 11.4.1.		N/A	<p>No hydrocarbon spill incidents were reported for the audit period.</p> <p>Evidence:</p>	Y	None	N

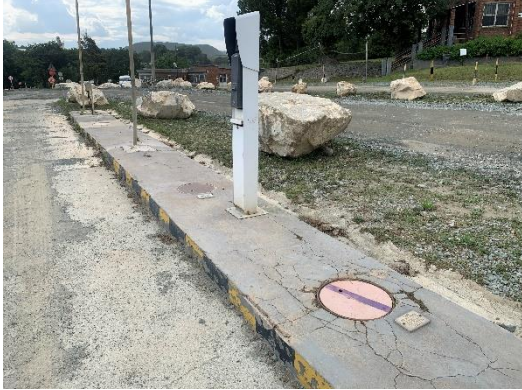
<p><b>Figure 2-14 - Diesel tank storage and refuelling points</b></p>					
		Monitoring volumes: Take dipstick readings to determine volume of fuel in the tank.	Daily	C	<p>Diesel tank volumes are measured daily and captured in a comparison spreadsheet.</p> <p><i>Evidence:</i></p> <ul style="list-style-type: none"> <li>Dip Stick Readings</li> </ul>	Y	None	N		
		Results will be compared with the previous day's readings and volumes of fuel pumped out (actual use).		C	<p>Diesel tank volumes are measured daily and captured in a comparison spreadsheet.</p> <p><i>Evidence:</i></p> <ul style="list-style-type: none"> <li>Dip Stick Readings</li> </ul>	Y	None	N		
		If discrepancies are identified, the structural integrity of the tank must be tested (i.e. vacusonic testing).	Within a week	C	<p>Diesel tank volumes are measured daily and captured in a comparison spreadsheet. No concerns regarding the structural integrity was identified.</p> <p><i>Evidence:</i></p> <ul style="list-style-type: none"> <li>Dip Stick Readings</li> </ul>	Y	None	N

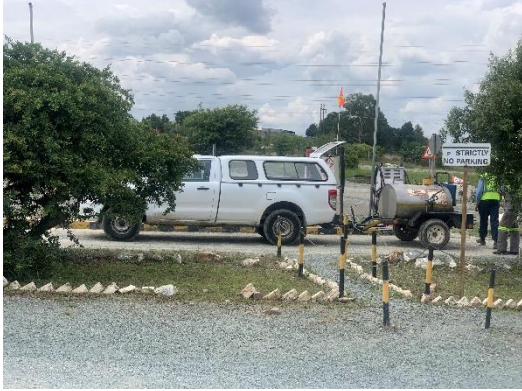
<p><b>Figure 2-15 - Staff presence during diesel delivery</b></p>					
		Inspections: <ul style="list-style-type: none"> <li>The structural integrity of the bund must be inspected and any cracks must be repaired immediately.</li> </ul>	Monthly	C	No major cracks requiring corrective action were seen on the bunds observed during the site inspection. <i>Evidence:</i> <ul style="list-style-type: none"> <li>Onsite observation</li> </ul>	Y	None	N		
		<ul style="list-style-type: none"> <li>Ensure the outlet valve of the bund is closed at all times.</li> </ul>		C	The outlet valve was observed to be closed during the site inspection. <i>Evidence:</i> <ul style="list-style-type: none"> <li>Onsite observation:</li> </ul>

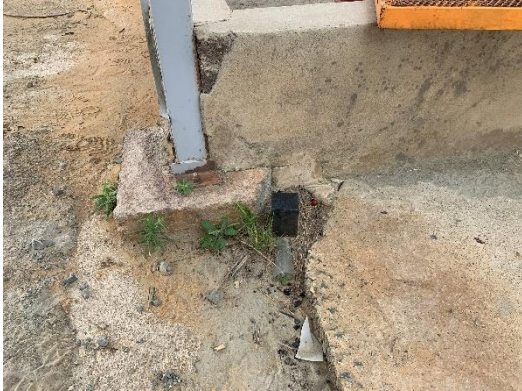
<p><b>Figure 2-16 - Locked bund valve</b></p>	Y	None	N

<ul style="list-style-type: none"> <li>The bunded area must be kept clear of excessive fines and vegetation.</li> </ul>		C	The bunded area was observed to be clear of excessive fines and vegetation. <i>Evidence:</i> <ul style="list-style-type: none"> <li>Onsite observation</li> </ul>	Y	None	N		
		The refuelling area must be visually inspected:	Weekly	C	The refuelling area was observed to be kept in good condition.	Y	None	N		
		All contaminated soils associated with spills will be dug up.		N/A	No spills or contaminated soils were reported for the audit period. <i>Evidence:</i>	Y	None	N

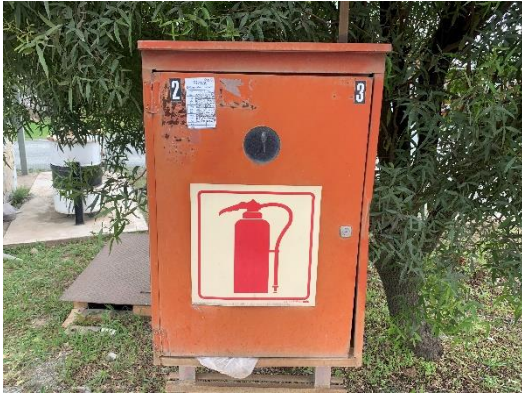
3.	Building fires	Fire extinguishers to be available in all buildings:	LoM	C	Several fire extinguishers were observed at different points throughout the site. <i>Evidence:</i> ▪ Onsite observation:

Y	None	N		
		Fire extinguishers to be checked by a qualified person.	Annually	C	The fire extinguishers are serviced monthly and signed. <i>Evidence:</i> ▪ Onsite observation	Y	None	N		
		If the fire cannot be controlled by the person who discovers the fire, it will be reported to the emergency services.		N/A	There were no fires reported during the audit period. <i>Evidence:</i> ▪ Verbal confirmation	Y	None	N		
<b>11.4.4 Incident reporting</b>										
		In the event of an incident as defined in the NEMA19, the following steps must be taken (as per S 30 NEMA):  Step 1: S 30(3) "The responsible person <sup>20</sup> or, where the incident occurred in the course of that person's employment, his or her employer must forthwith after knowledge of the incident, report through the most effective means reasonably available —  a) the nature of the incident;  b) any risks posed by the incident to public health, safety and property;		N/A	No environmental incidents were reported during the audit period. <i>Evidence:</i> ▪ Verbal confirmation	Y	None	N
